# **Hunter Expressway Minefill**

Newcastle, NSW

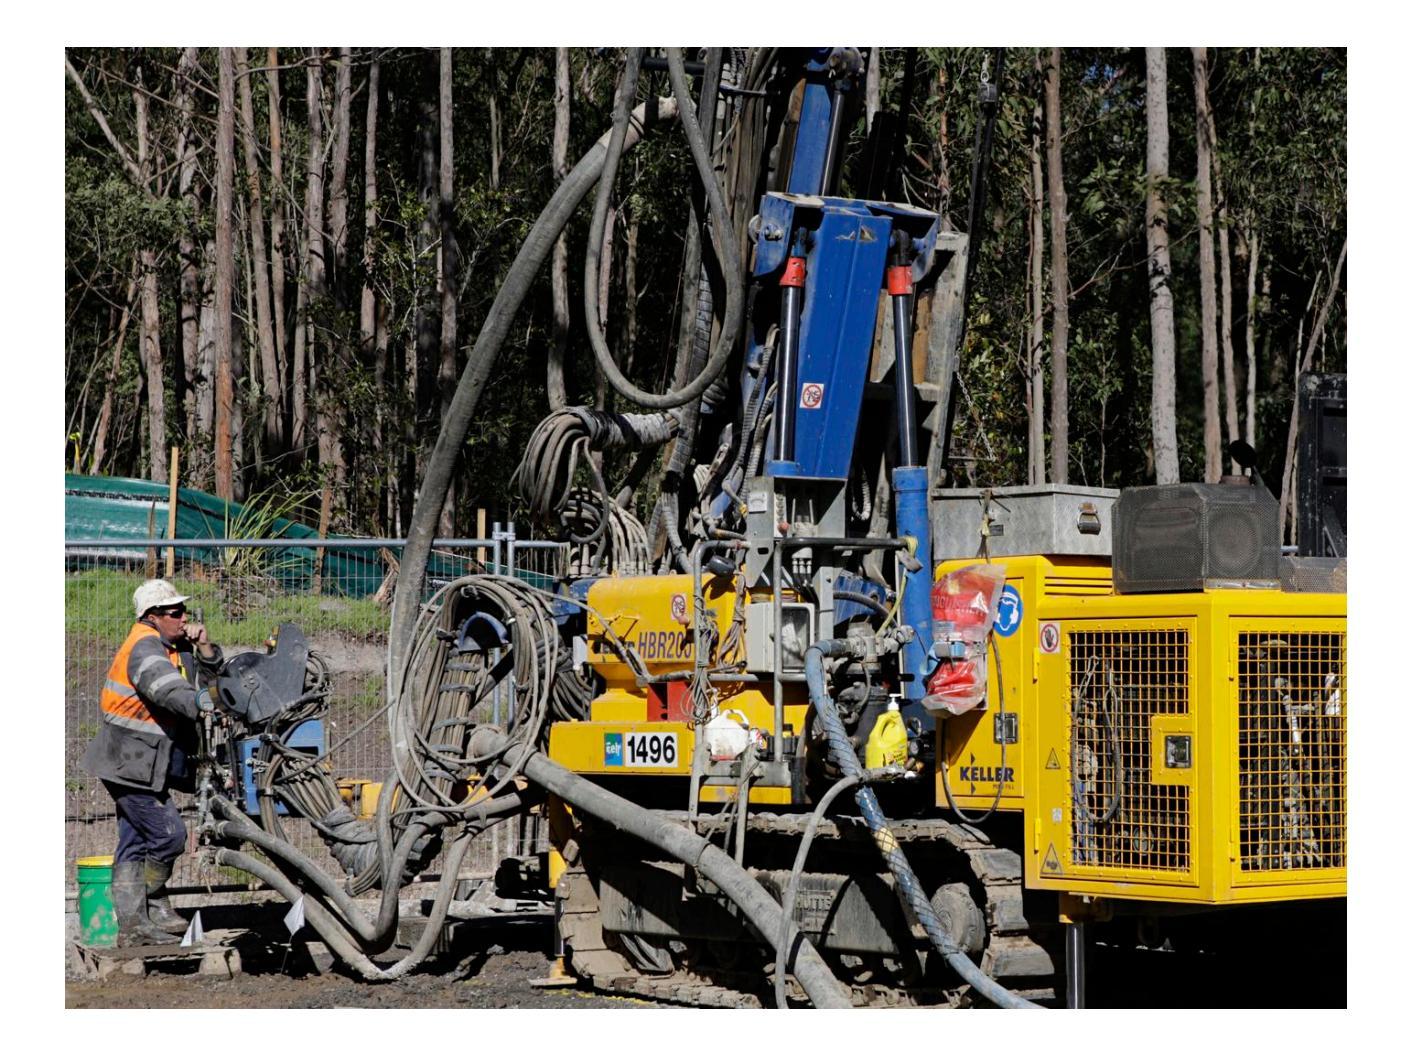
With the use of proprietary down-hole camera to confirm findings and grout voids together with inclined drilling systems allowed Keller to perform the mine filling without the need of clearing large areas of bushland.
